Elmhurst Condo Sustains Window Replacements

Windows shouldn't fail after just a decade, but for one Condo building located in Elmhurst, Illinois, it happened. A few small leaks were signs of widespread issues which eventually led to several window sashes actually falling out of the five story fifty-six unit building that was built in 2002. The condominium building is a structure clad in brick, limestone, cast stone, fiber cement siding, and 192 vinyl-clad wood windows.

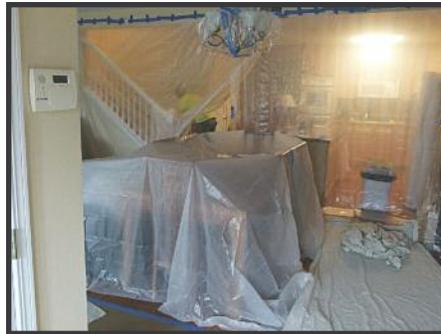
➤ Shown here is the inside of a condo unit protected with plastic covering to avoid any damage during window replacement work.

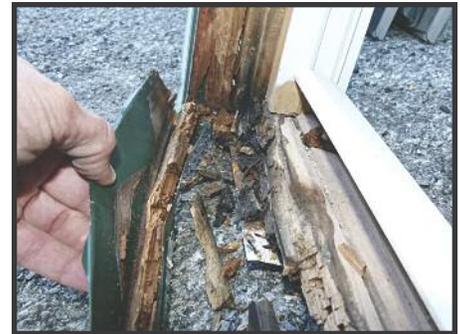
➤ Shown here is one of the window sills that had rotted wood from water penetration and caused a potential hazard of a window falling out.

During the investigation, BTC observed hair-line cracks and tears in the vinyl cladding materials at many of the windows. They also observed displaced and/or discontinuous vertical trim strips, unsealed and missing mull end caps, deteriorated window perimeter sealant, and water-damaged interior window trim. Exploratory openings through the vinyl cladding revealed rotted wood window framing.

Reicher adds, "Deterioration of the wood window framing was primarily attributed to water penetration at the hinge hardware fasteners and displaced mull strips. During our evaluation, approximately 30% of the windows were found to have loose hinges. At these locations, water can penetrate through the holes in the vinyl cladding and saturate the wood frame. The sashes at many of these locations were not adequately attached to the wood frames, and were susceptible to falling from the building."

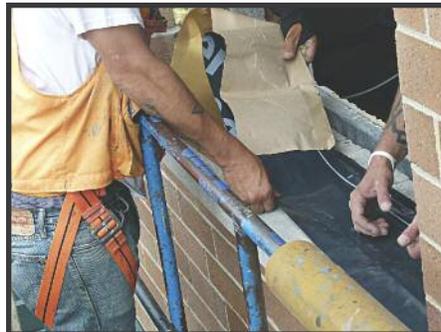
➤ Window perimeter sealant was installed around the interior and exterior of the windows to limit air leakage through the gap between the window frame and building.

- » Sheet metal pan flashing assemblies included a thermal break to improve thermal performance of the window systems.
- » Window perimeter sealant was installed around the interior and exterior of the windows to limit air leakage through the gap between the window frame and building.

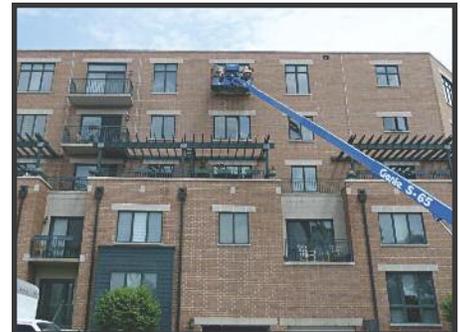
➤ Shown here is the installation crew using their articulating boom lift to place a new window.

that ranged from small twin casements which are 4'X5' to a larger composite of 7'X7' in size. Mariotti adds, "We actually brought the windows up utilizing our own articulated lift to raise the new windows up to the openings from the exterior."

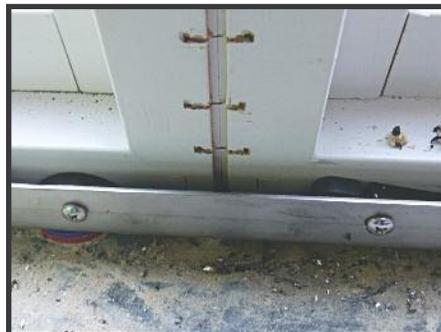
➤ Shown here is the pan flashing assembly back dam. Screws were used to attach the back dam to brackets installed along the window sill.

brackets that could be anchored directly to the rigid pan flashing back dam, thus ensuring no penetrations through the pan flashing horizontal drainage surface. Therefore, the pan flashing assembly served two purposes: It provided a drainage system below the windows, and also allowed for window anchorage along the sill.

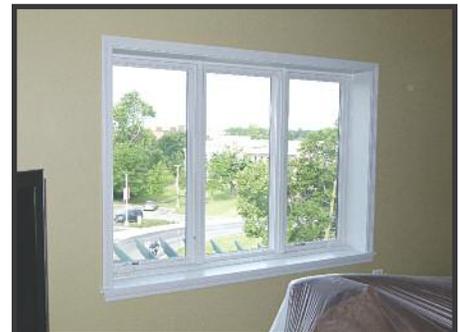
➤ Shown here is a view of one of the new windows from inside the condo unit.
